**UNITED STATES ENVIRONMENTAL PROTECTION AGENCY  
REGION 5**

**SUBJECT:** INSPECTION REPORT – Century Plating Company, Inc., Chicago, IL

**Date of Inspection:** December 5, 2013

**Purpose of Inspection:** The purpose of the inspection was to investigate compliance of Century Plating Company, Inc. (Century) with the National Emission Standards for Hazardous Air Pollutants for Chromium Emissions From Hard and Decorative Chromium Electroplating and Chromium Anodizing Tanks at 40 C.F.R. Part 63, Subpart N.

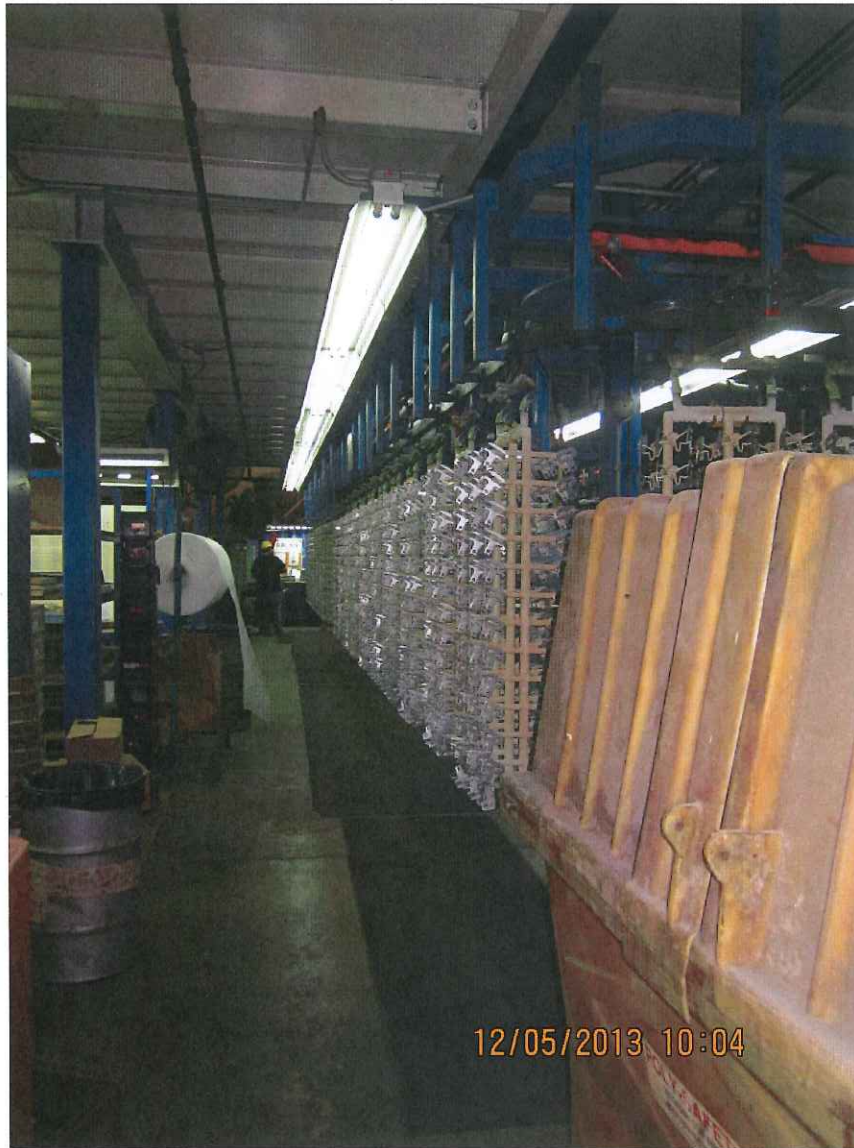
We exited the conference room at about 10:00 am to begin the facility tour. We began the tour at Line 2. Century employees load the parts on hanging racks for plating. During the inspection, Century was plating seat belts (Photo 1). Mr. LaPorta led us to Line 2 and stated that each line has roughly 25 – 35 stations which include alkaline cleaner tanks, electro cleaner tanks (Line 1 has current), electro acid tanks, water rinse tanks, neutralizer, and a small acid tank.

Photo 1: Racks of seat belts waiting to be plated on Line 2.

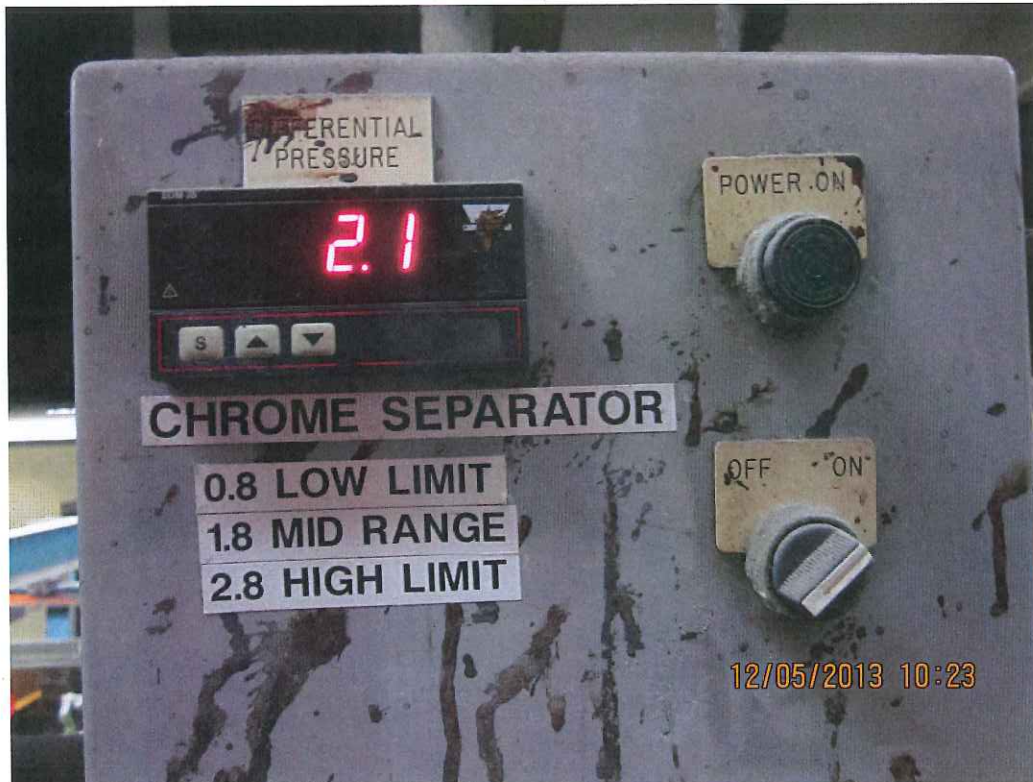
We proceeded to Line 1. I noted a stronger odor on Line 1. Mr. LaPorta stated that Century uses nitric acid to strip the racks after plating. Line 1 is composed of a 20,000 gallon nickel plating tank; 4,500 – 4,700 gallon bright nickel tank and a 1,600 – 1,700 gallon nickel tank. While on Line 1 we walked by the digital read out for the chromium separator which displayed a differential pressure of 2.1 (Photo 4). Mr. LaPorta stated that Century has a scrubber on each nitric acid tank,

Photo 4: Digital read out of the chromium separator pressure drop on Line 1.

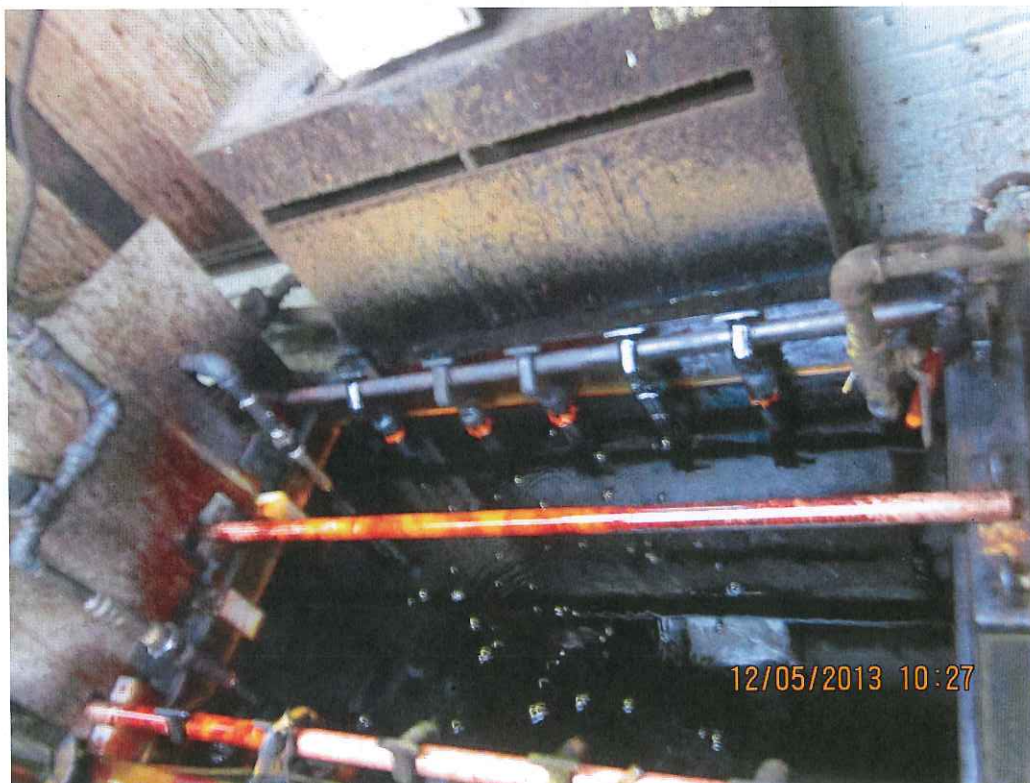
We proceeded to the 1,300 gallon decorative, hexavalent chromium tank on Line 1 (Photos 5 and Photo 6), used for hand plating. This chromium tank is connected to the scrubber on Line 1.

Photo 5: Decorative, hexavalent chromium tank on Line 1.

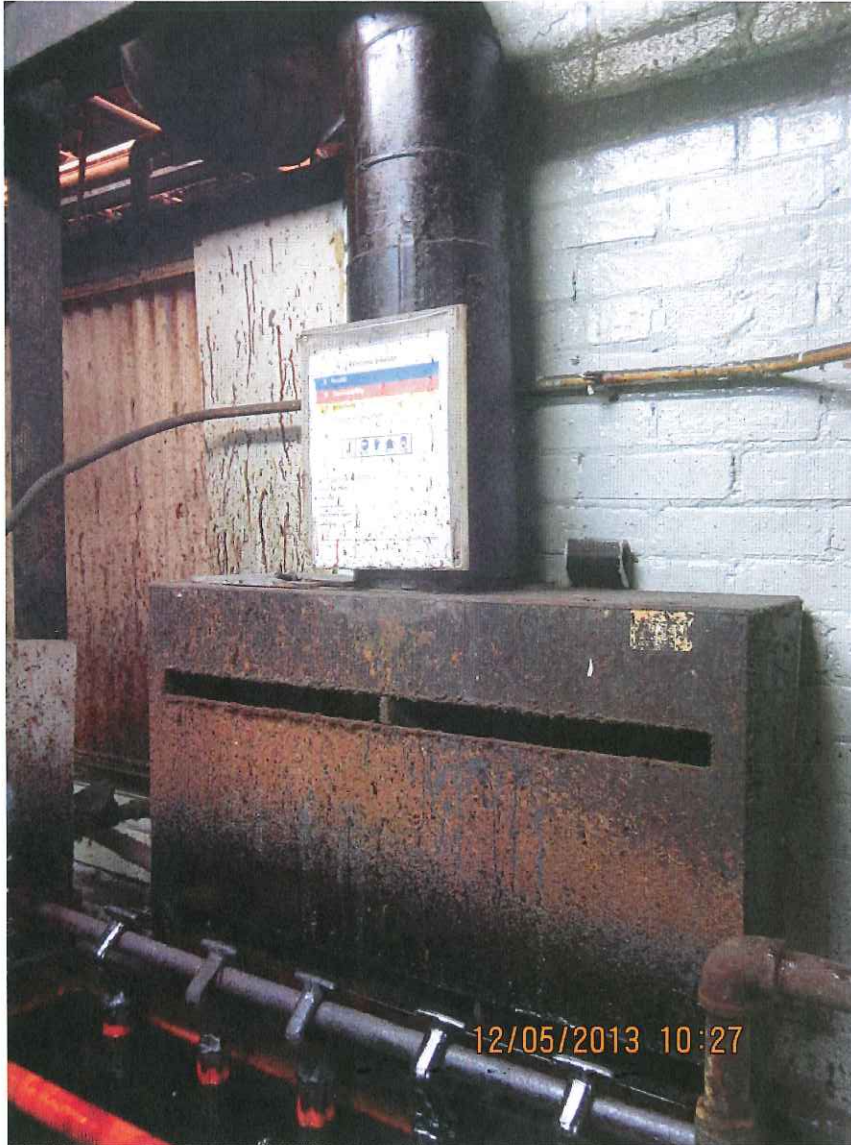
Photo 6: Intake on the decorative, hexavalent chromium tank on Line 1.
